ANNUAL REPORT FOR 2002

Spring Branch Mitigation Site

New Hanover County

Project No. 8.2250109

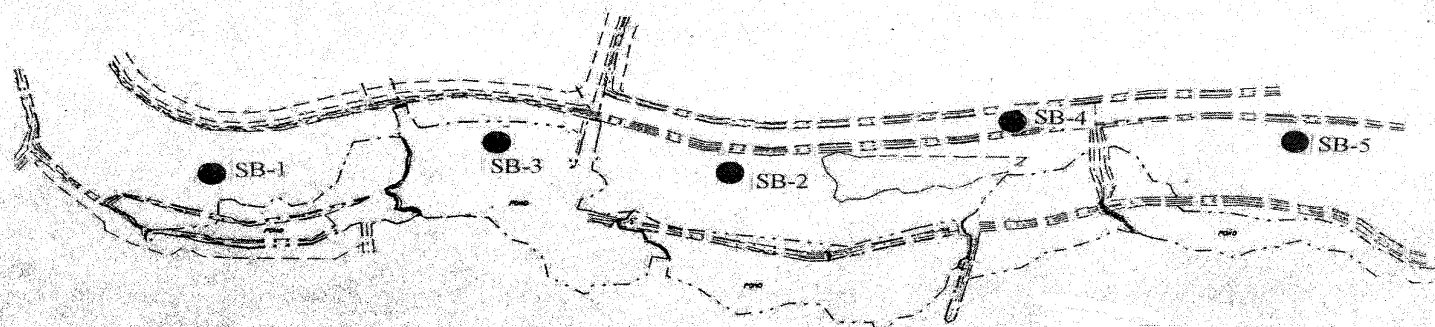
FIGURE 2
SPRING BRANCH
GAGE LOCATION MAP

Three monitoring gauges, two surface gauges, and one rain gauge were installed in March of 1998 (Figure 2). Because of the amount of surface water on the site, each groundwater well was installed to record water levels both above and below ground level. Daily readings are taken throughout the growing season.

SB-1 GROUNDWATER GAUGE
SB-2 SURFACEWATER GAUGE
SB-3 GROUNDWATER GAUGE
SB-4 SURFACEWATER GAUGE
SB-5 GROUNDWATER GAUGE

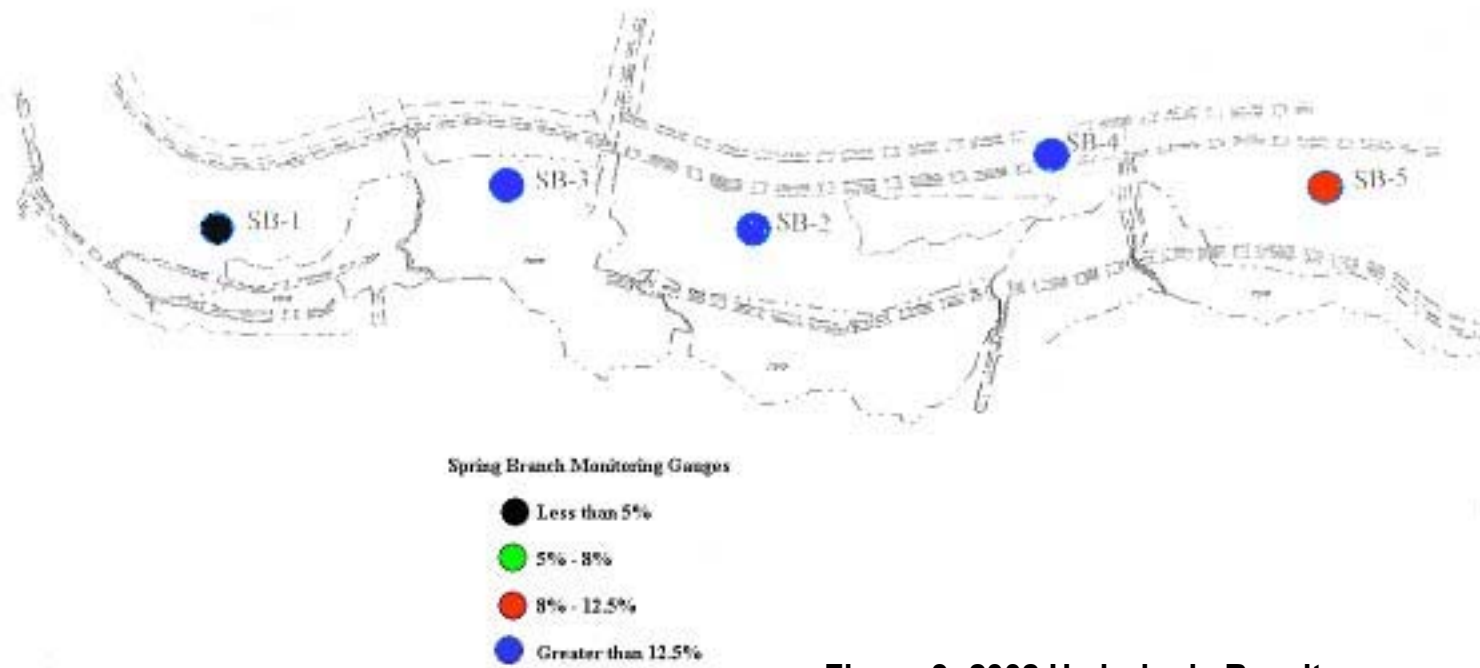
Figure 3: 2002 Hydrologic Results

Monitoring Well	< 5%	5% - 8%	8% - 12.5%	> 12.5%	Actual %	
SB-1	✓				.74	
SB-3				✓	48.7	2/26-6/5 7/18-11/26
SB-5			✓		11.8	6/29-7/16 10/14-11/14

During the growing season from February through November 2002, SB-3 met the optimum jurisdictional hydrologic success of at least 12.5% during the growing season. SB-5 showed saturation between 8 and 12.5% of the growing season, while SB-1 showed saturation less than 5% of the growing season. The surface water gauges indicated a consistent presence of surface water throughout the growing season. During the 2002-monitoring year, the site experienced a below average rainfall. The beginning of the growing season is the most critical time for a site; this is when the gauges will most likely meet success due to the recharge of rainfall before the growing season. When the rainfall for these months is below average, then the rain never fully recharges causing saturation levels to decrease. Two of the gauges at Spring Branch experienced difficulty meeting optimum success due to the dry climatic conditions for 2002. However, the previous four years of data indicates that the site has met hydrologic success.

Figure 3 represents a graphical representation of the hydrologic results. Gauges highlighted in blue indicate wetland hydrology for more than 12.5% of the growing season. Gauges highlighted in red show hydrology between 8% and 12.5% of the season, while those in green indicate hydrology between 5% and 8% of the season. Gauges highlighted in black indicate no wetland hydrology (less than 5% of the growing season).

During the 2002-monitoring year, the site experienced below average rainfall. For this reason two of the gauges (SB-5 & SB-1) experienced difficulty meeting success due to the dry climatic conditions for 2002. SB-3 met jurisdictional hydrologic success of at least 12.5% during the growing season. The surface water gauges indicated a consistent presence of surface water throughout the growing season. Based on the past 5 years, the site has demonstrated hydrologic success and is classified as a wetland. Therefore, the department proposes to discontinue monitoring at this site.

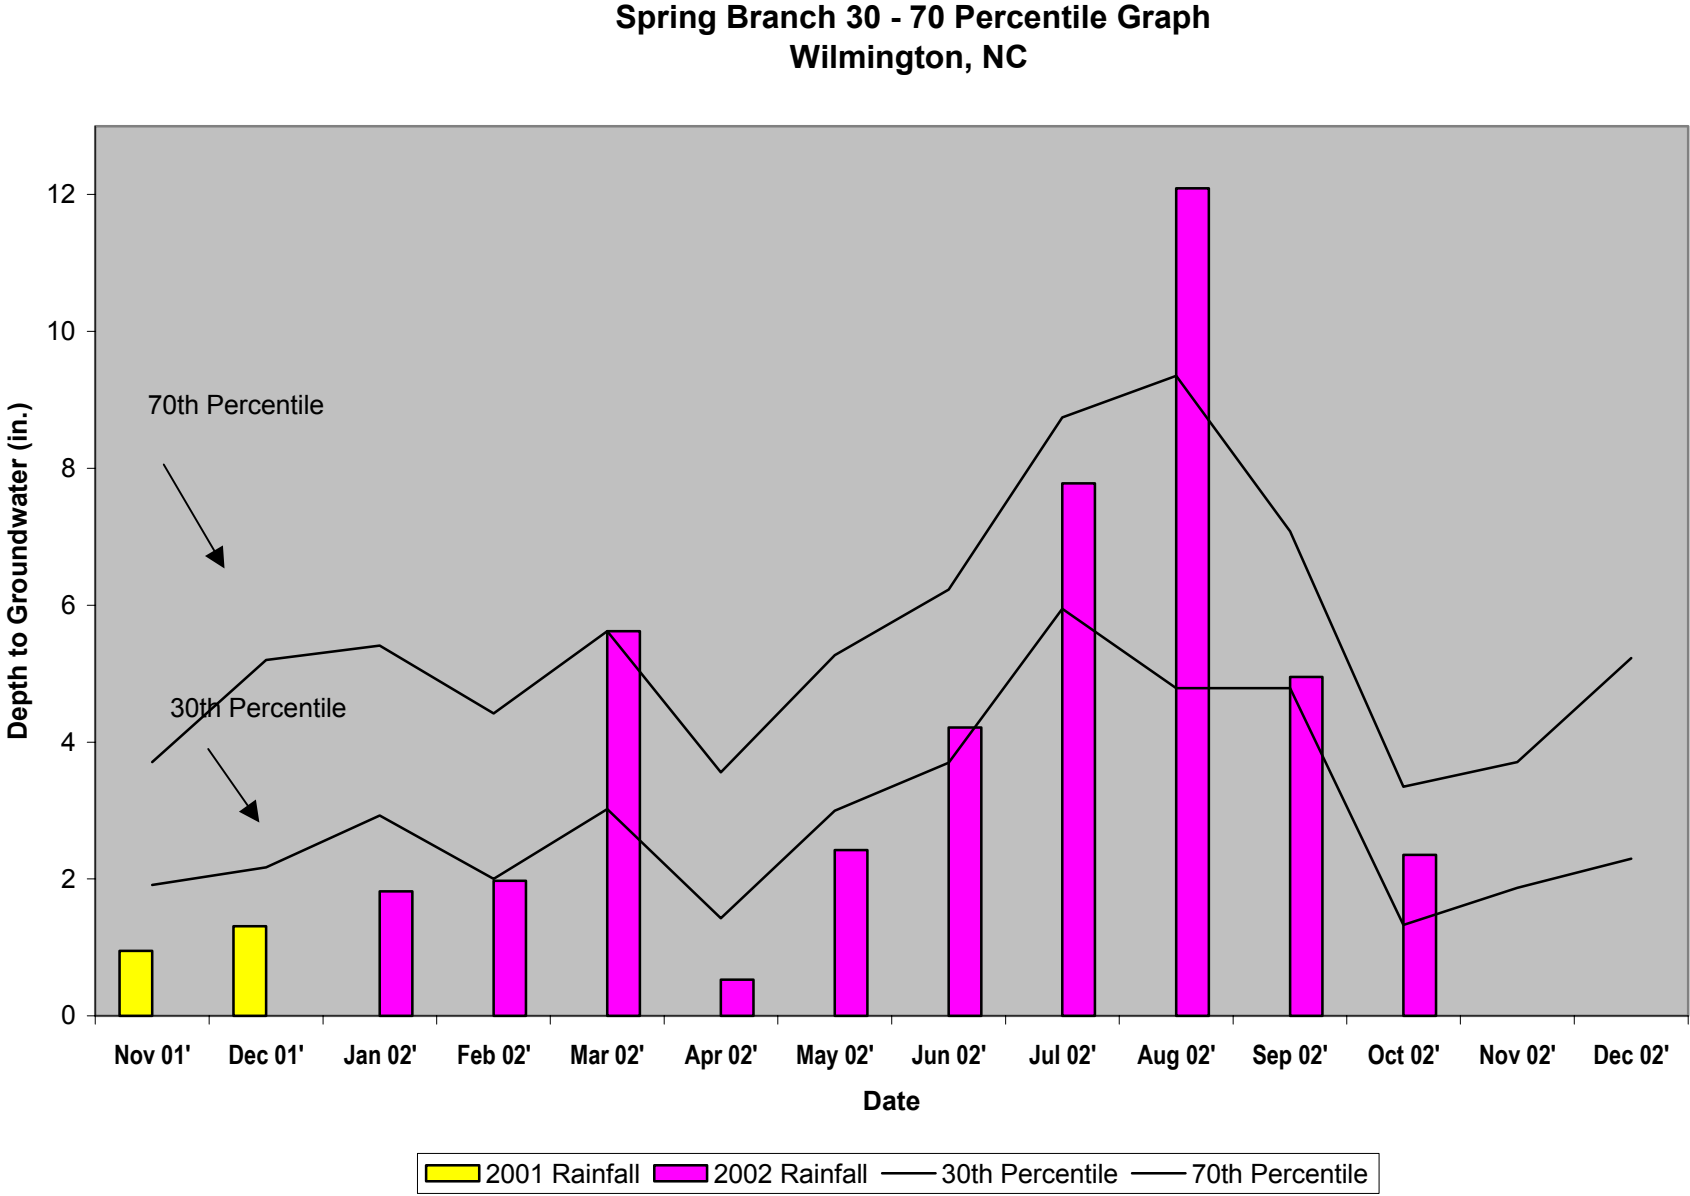
Figure 4: 2002 30-70 Percentile Graph

Figure 4 represents an examination of the local climate in comparison with historical data in order to determine whether 2002 was “average” in terms of climate conditions. The two lines represent the 30th and 70th percentiles of monthly precipitation for Wilmington, NC. The bars are monthly rainfall totals for 2001 and 2002. The historical data was collected from the State Climate Office of North Carolina.

The months of July, September and October were considered “average”. November 01, December 01, January, February, April, May, and June were considered below “normal”. March and August were above “normal” months. Overall the site experienced below average rainfall in 2002
